## Restoration of Mires (bogs and fens) in the Australian Alps following domestic stock grazing and the impacts of the 2003 wildfires.

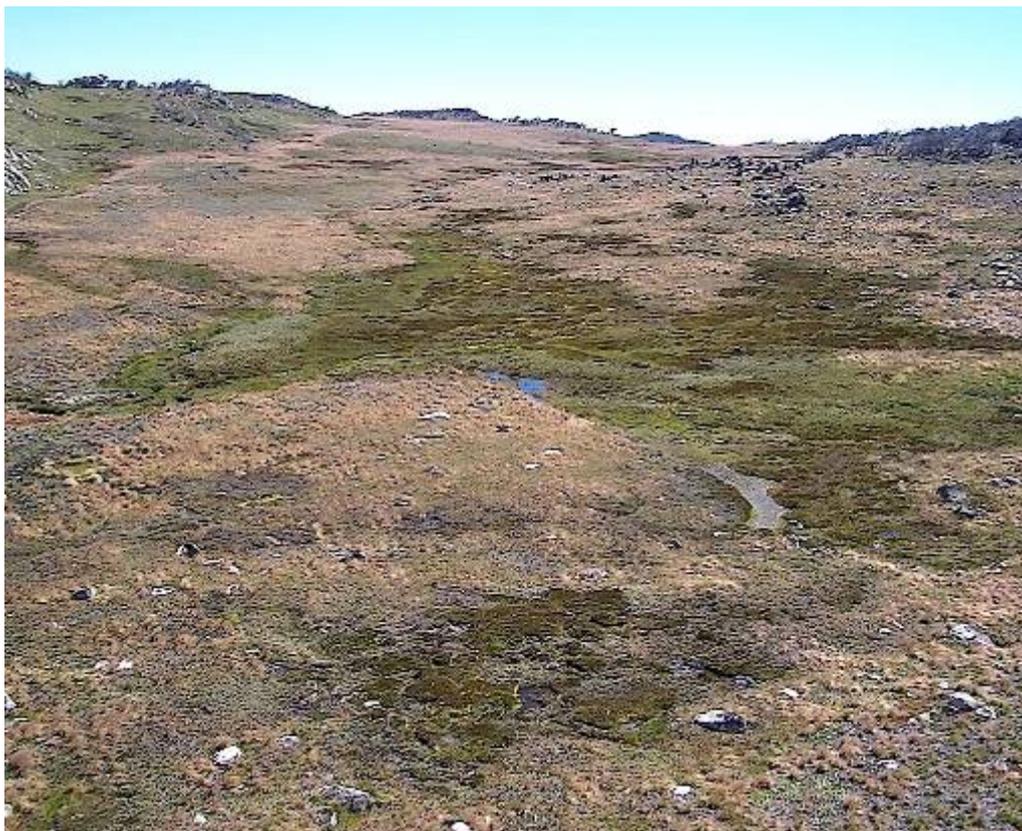
Figure 2 A large valley bog extensively burnt during the 2003 bushfires.

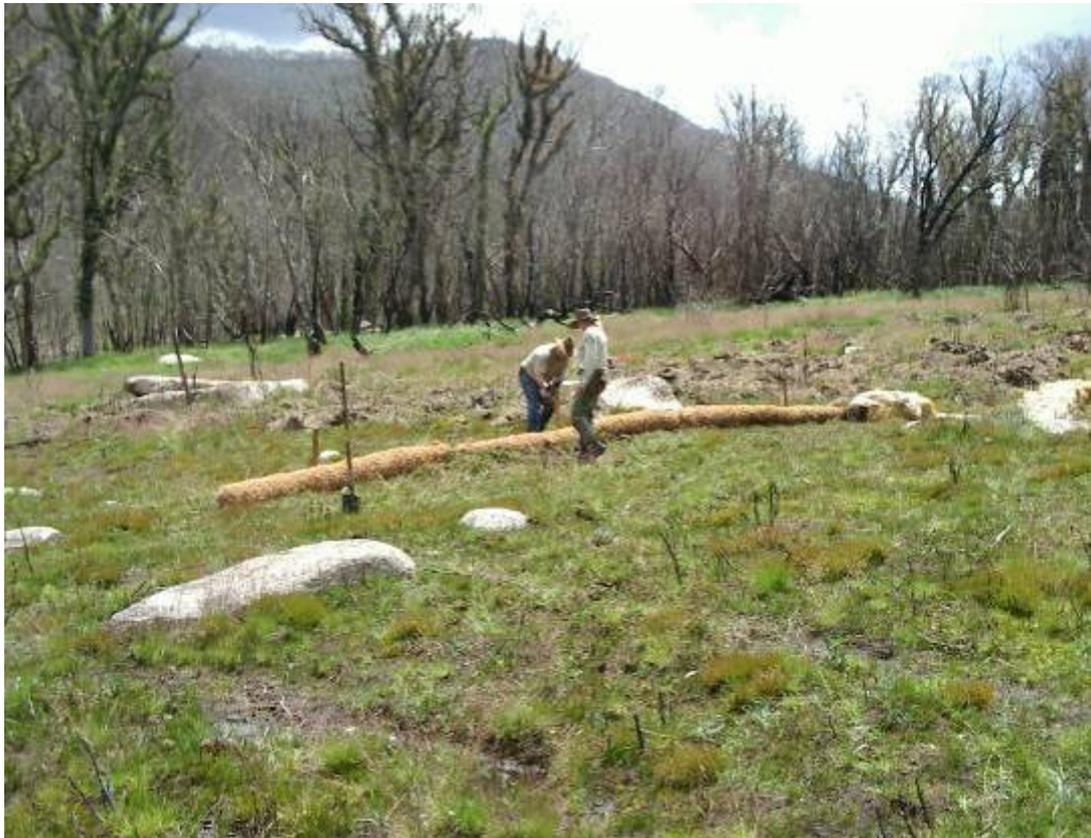
logs and straw bales across the slopes above the bogs. These structures diverted excess flows while the porous structure of the coir logs and straw bales provided for leakage through them into the bogs and fens (fig 3).

Figure 3. Coir logs placed on the contour to prevent flow-line formation and to act as water-spreaders of surface runoff into bogs and fens.

The initial works at each site was to identify any entrench flows into the bogs and fens and to plan a system of water spreading works such that flows into the bogs were slowed and spread across the entrant slope. This was done to reduce the potential for flowline incision through the bogs and fens as a result of concentrated and high flows; or to reduce flows through any bogs already heavily incised.

Where water-spreading was required it was achieved through the placement of coir

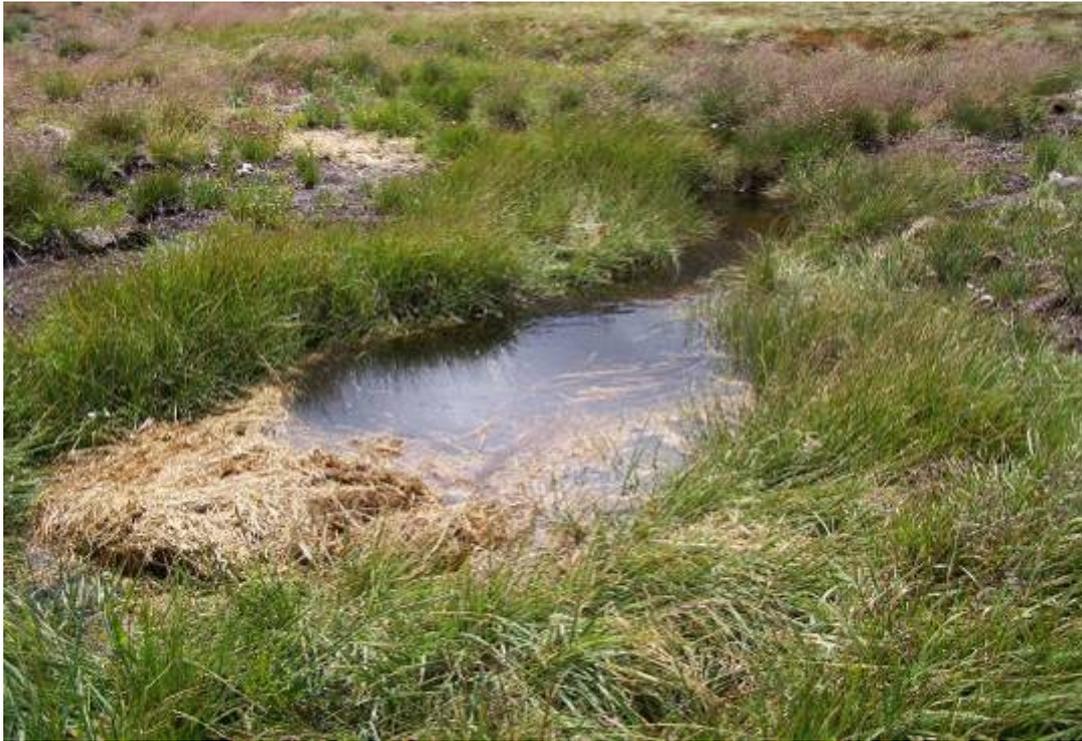
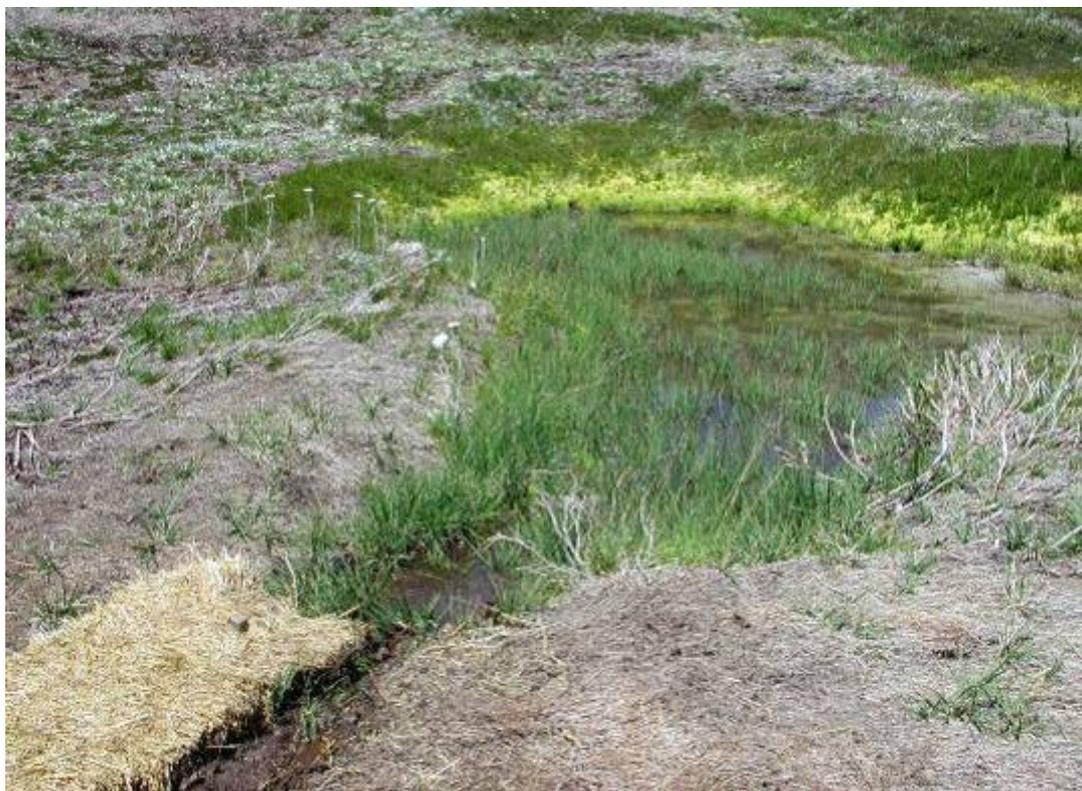
Figures 4 and 5. Hay bales inserted into low rate flow areas, to spread water into the surrounding peatlands and to form stable pools for the re-establishment of fringing *Sphagnum* hummocks.

Immediately after the fires heavy rainfall events were expected and did occur resulting in increased run-off flows, this causing flowline incision, deep channel development and destruction and loss of the natural pools within the bogs and fens. The techniques to prevent flowline incision within the bogs and fens involved the placement of straw bales in inflow and outflow channels to recreate surface ponding and slowing of the flows from the sites. The ponding provided the opportunity for regeneration of a fringing water- edge *Sphagnum* community and re-saturation of the underlying peatbeds (figs 4 & 5)

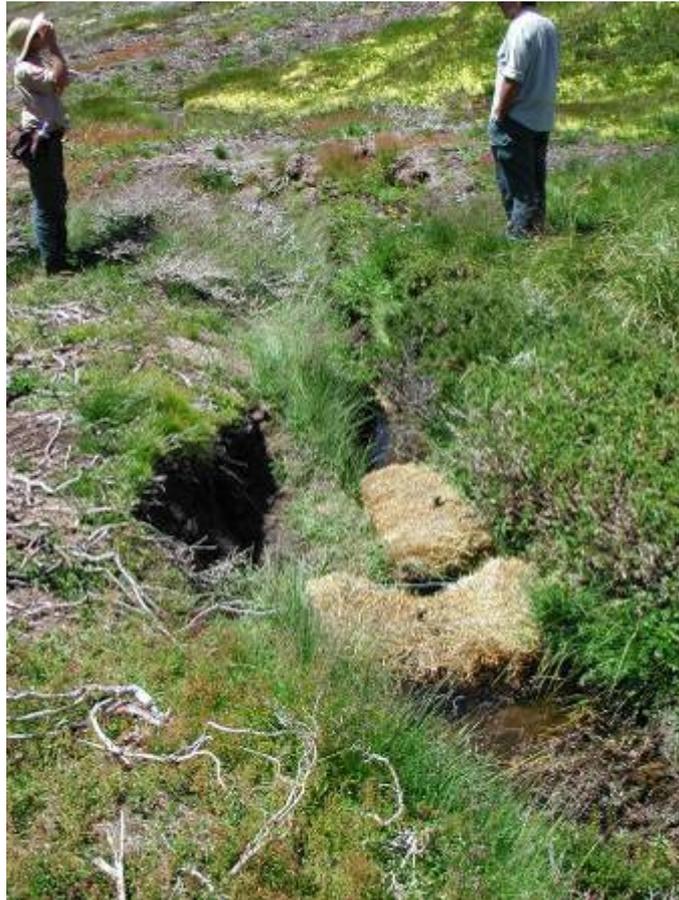
Figure 6. Three or four layers of straw bales packed into an incised flowline to prevent lateral undercutting and peat collapse.

In areas where high flow rates and substantial vertical incision of the peat had developed, channel depths of a metre or more were evident. It was also found that once incision to bedrock had occurred, lateral erosion of the peat up to two metres either side of the incised flowline was evident, with subsequent peat collapse and loss of the peat from the site if no remedial action was taken.

Reducing flows in these areas was also achieved through the packing of straw bales into the incised flowlines (fig 6), with hessian bags filled with straw being inserted into areas of undermined peatbeds, to provide support for the peat.

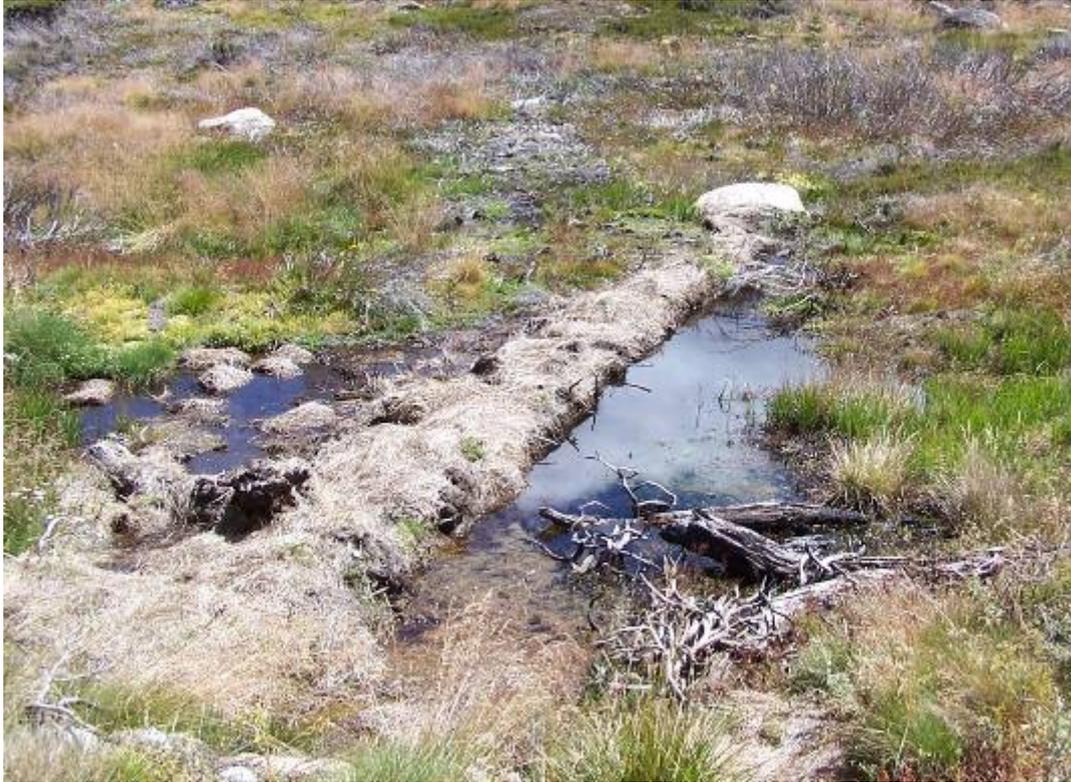
Figure 8. One hundred metre long subsurface ‘straw-bale dam’ (partly exposed for demonstration) to assist the retention of inflows in the peat during resaturation.

In several large dehydrated and drained bog areas, trenches were cut through the peatbed down to the underlying gravels or bedrock (1 to 2.5 m) and then filled with one to three levels of straw bales (fig 8). This was done to provide a subsurface semi-impervious organic ‘dam’ to assist the wetting of the peats from surface and subsurface inflows. After placement the straw bales were covered with sods of peat and bog vegetation (*Sphagnum*, *Carex* and *Empodisma spp*), the straw bales eventually decomposing, and being incorporated into the peat mass. This was a drastic measure to impose on several bog areas but was deemed essential if the bogs were to regain their water-holding capacity and their hydrological functioning effectively restored. This technique has achieved its goals, with no apparent or obvious detrimental impact on the structure of the mires.

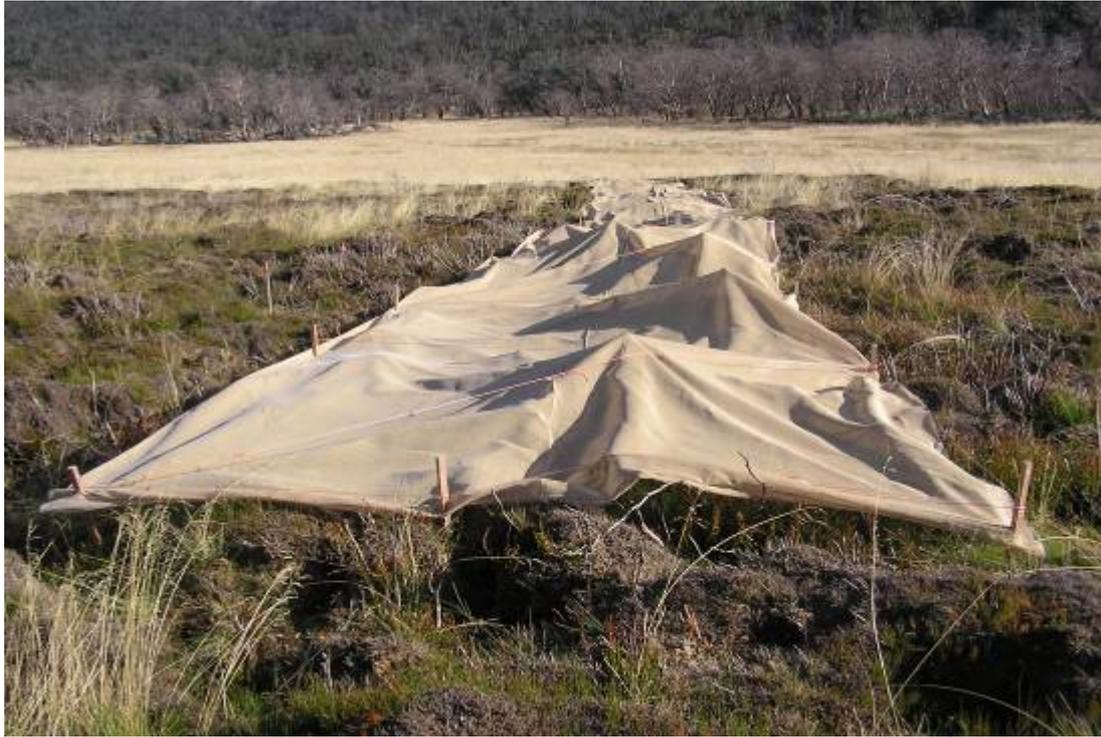
Figure 8. A 600 square metre shade cloth cover over core *Sphagnum* hummocks in a significant bog site.

Initially, in order to further increase the potential for *Sphagnum* recovery, sterilized straw-mulch was spread over remnant *Sphagnum* hummocks that exhibited some post-fire recovery. The straw was spread at a rate of approximately 2 tonnes per hectare, loosely spread to a depth of 3-5cm. This rate of application provided approximately 70% shading for the underlying vegetation; a level of shading previously identified as optimal for initiating and enhancing *Sphagnum* regeneration.

Due to the difficulty of transporting heavy and bulky straw bales to remote sites, commercial shade cloth (fig 8) was trialled and was found to be a suitable alternative, being easier to apply and longer-lasting than the straw shading material. Some 6000 square metres of shade cloth has been placed over *Sphagnum* hummocks in bog and fen sites in Kosciuszko and Namadgi National Parks with noticeable benefits to plant growth and health, evident after only two years.
