Review of Toilet Systems within the Australian Alps.

Prepared by
Johnston Environmental Consultancy Pty Ltd

March 2001

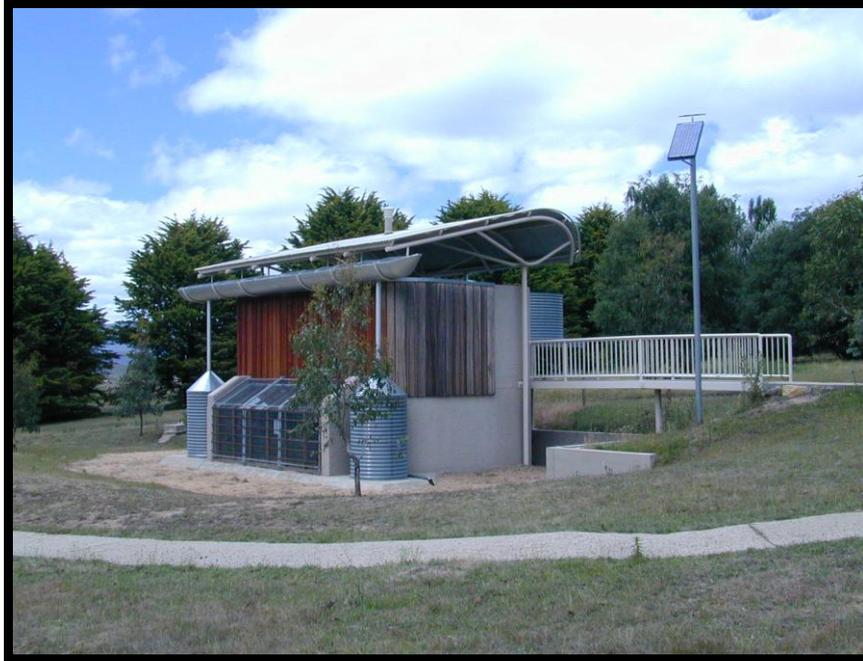
Clivus Multrum Toilet Systems

Clivus Multrum composting toilets have been operating in all climatic conditions in Australia for over 20 years and is the largest selling public facility composting toilet in the world. However, across the Australian Alps a mixed response was found to this system. At lower altitudes in the ACT and Victoria the system was seen to function moderately well, however at higher altitudes in NSW the system was seen to function very poorly.

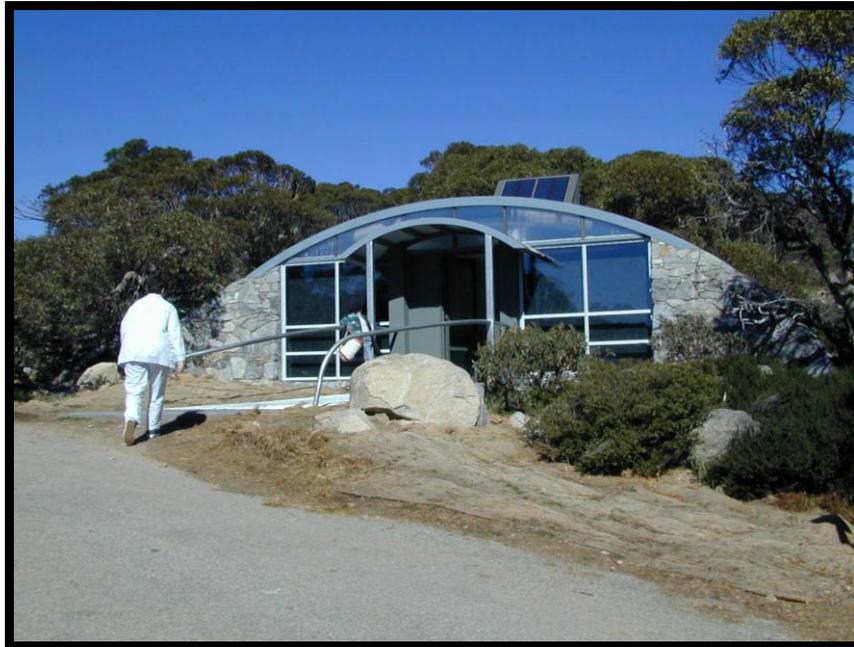
Integrated Eco-Village Toilet System

The Integrated Eco-Village composting toilet at Charlottes Pass is a purpose built structure containing a modified Downmus toilet system, that was designed to provide an ecologically sustainable system in one of the most visited summer destinations in the Australian Alps in the coldest environment found on the Australian continent. The facility contains 2 female pedestals, 1 male pedestal, 1 male urinal and 1 disabled pedestal with all pedestals designed to separate the urine and faeces. The facility is also equipped with a solar air pre-heater, urine holding tank, which can be pumped out, a recycling pump, moisture monitor, temperature probe connected to the fan, and damper for re-circulating the air. The toilet building is designed to facilitate the solar air pre-heater, ensuring that the compost chamber is insulated and maintained at a stable temperature.

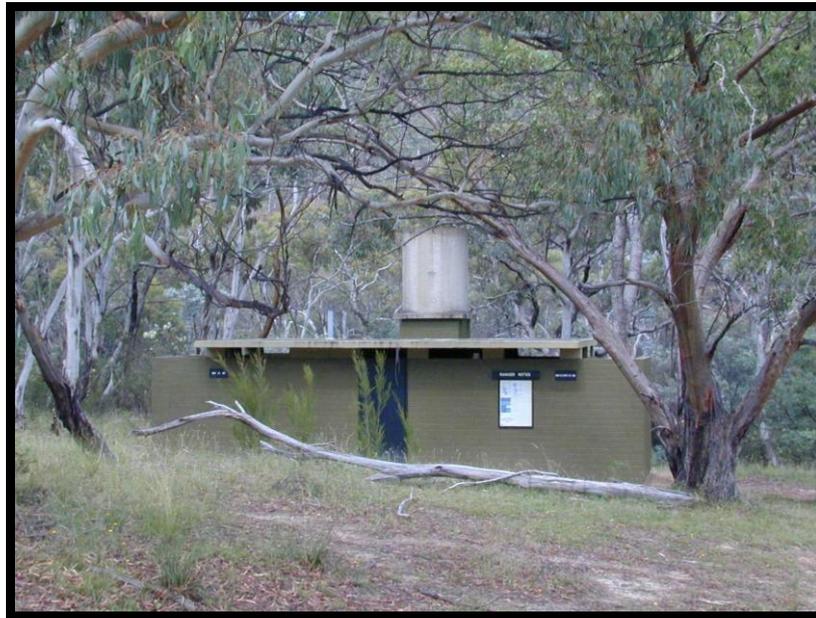
SEPTIC TOILET SYSTEMS

In the Australian Alps National Parks, public septic toilet systems are found only in a few locations with the majority of these found within the ACT. These facilities were a response to increasing demands on the more accessible areas of the Alps due to the urban growth of Canberra during the 1960s and 70s. These facilities consisted of four flushing toilets, equally shared between male and female, surrounded by concrete block walls and a reinforced concrete roof. External features include a water tank filled from a stream or water source and a septic tank with associated dispersal trenches.

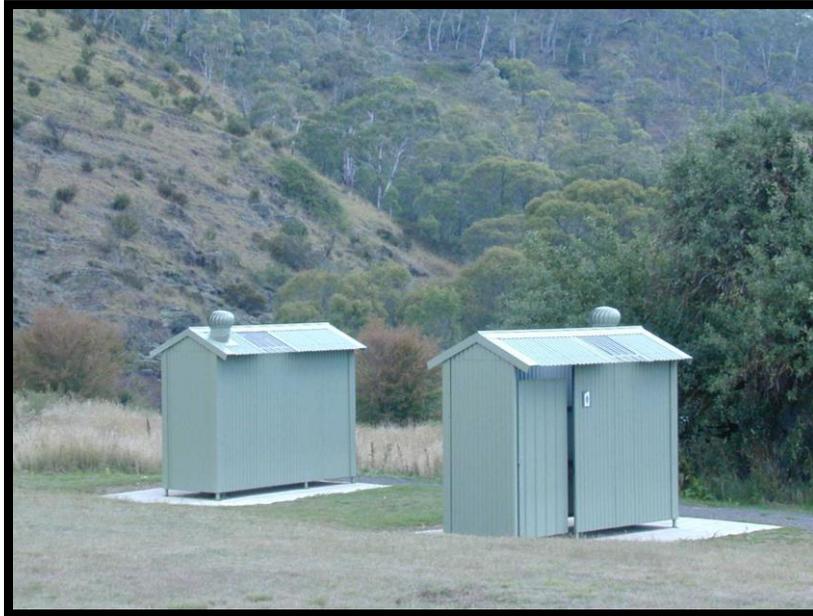
PIT TOILET SYSTEMS

A traditional pit toilet found within the Australian Alps National Parks consisted of a hole in the ground, over which a concrete slab (usually), frame, pan and seat and roof were installed. These toilets were notoriously smelly, the pit contents leaked out into the surrounding ground water, and the frames were prone to vandalism and weather. Maintenance on these units is high. Pumping these toilets out was also very difficult as the liquid waste usually leached away leaving the solid waste in a hard block. This required the toilets to be filled with water 2 to 3 days before the toilet was pumped out so complete pump-outs were possible. Again this was very maintenance intensive. Changes in environmental legislation and more effective toilet design have meant that the traditional unsealed pit toilet is being replaced by other designs, including sealed tank units.
