NEWS FROM THE ALPS

THE ALPS PROGRAM: WORKING
TOGETHER BEYOND BORDERS

LIGHTLY ON THE LANDSCAPE

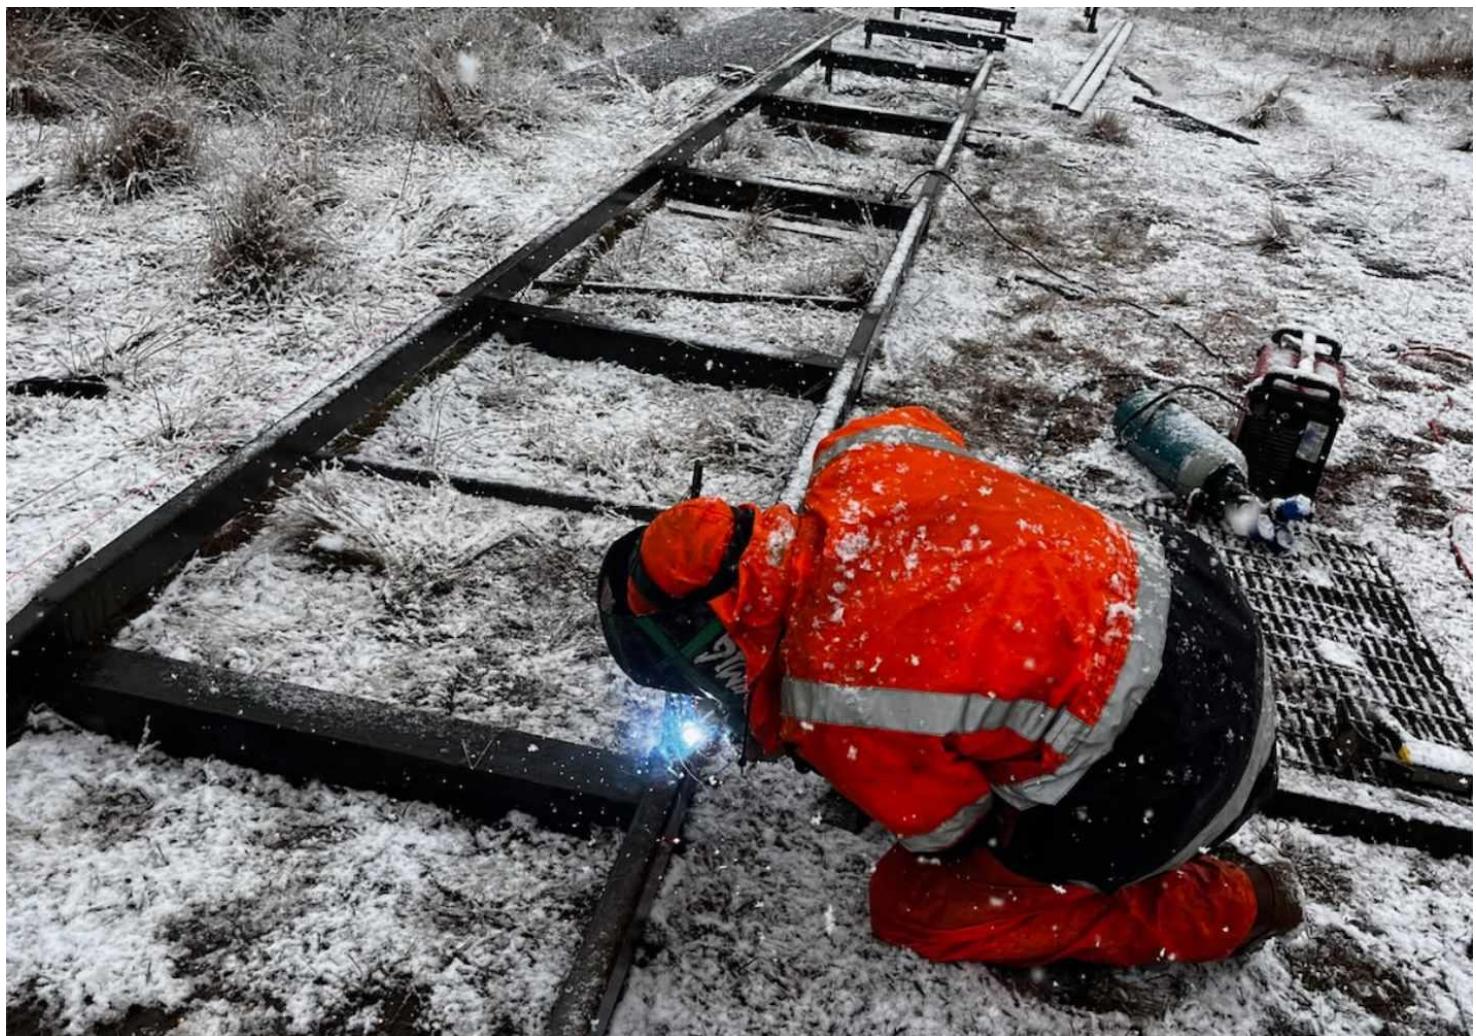
Working in all weathers, specialist contractors have spent the last six months gently laying onto the landscape a customised, fire-resistant track up to the Yankee Hat rock art precinct.

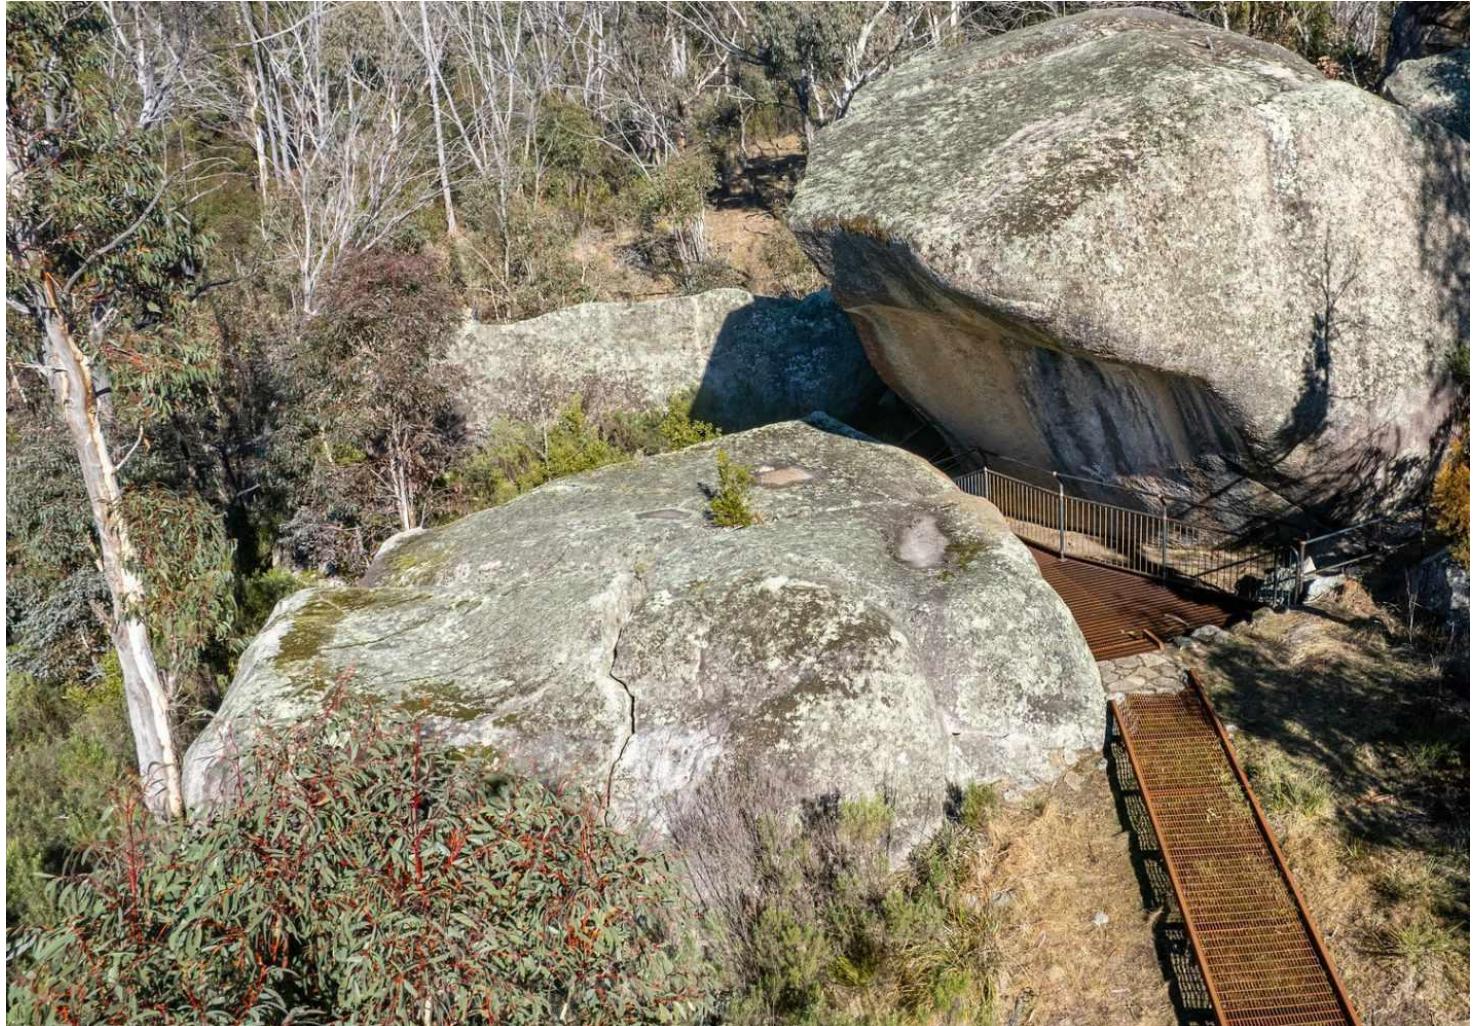
The rebuilt track meets the new viewing platform in a way that sits more gently in the space.

"We went in aiming to build-back-better, using fire resistant materials – steel and rock. As part of the walking-track rebuild, we included a steel footbridge and board walks over the swampy areas. Timber steps were replaced with rock, and way-finders replaced in steel." But the jewel in the rebuild was

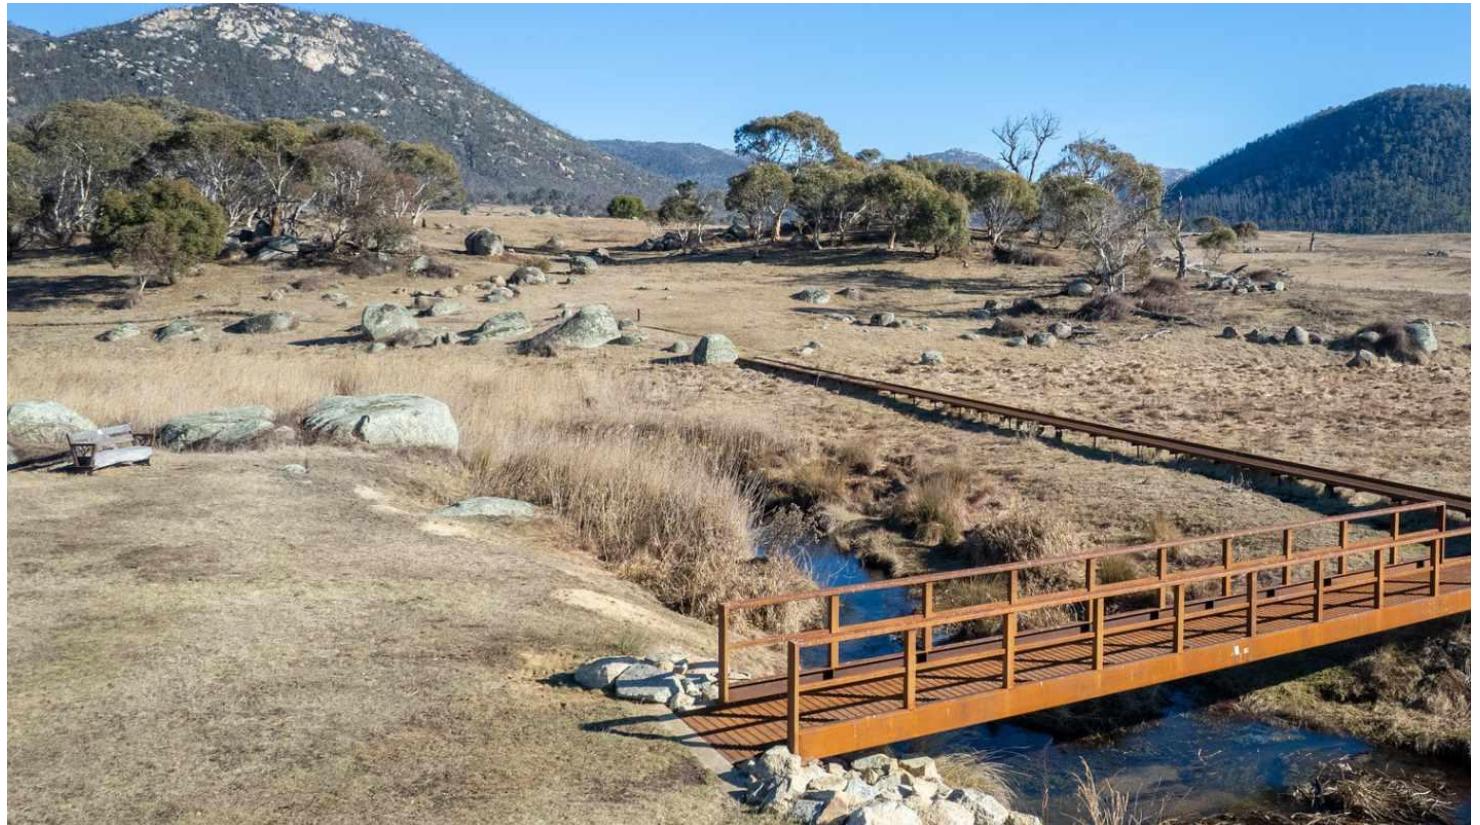
The stone and steel fabric of the new footbridge and boardwalks will better withstand future fires.

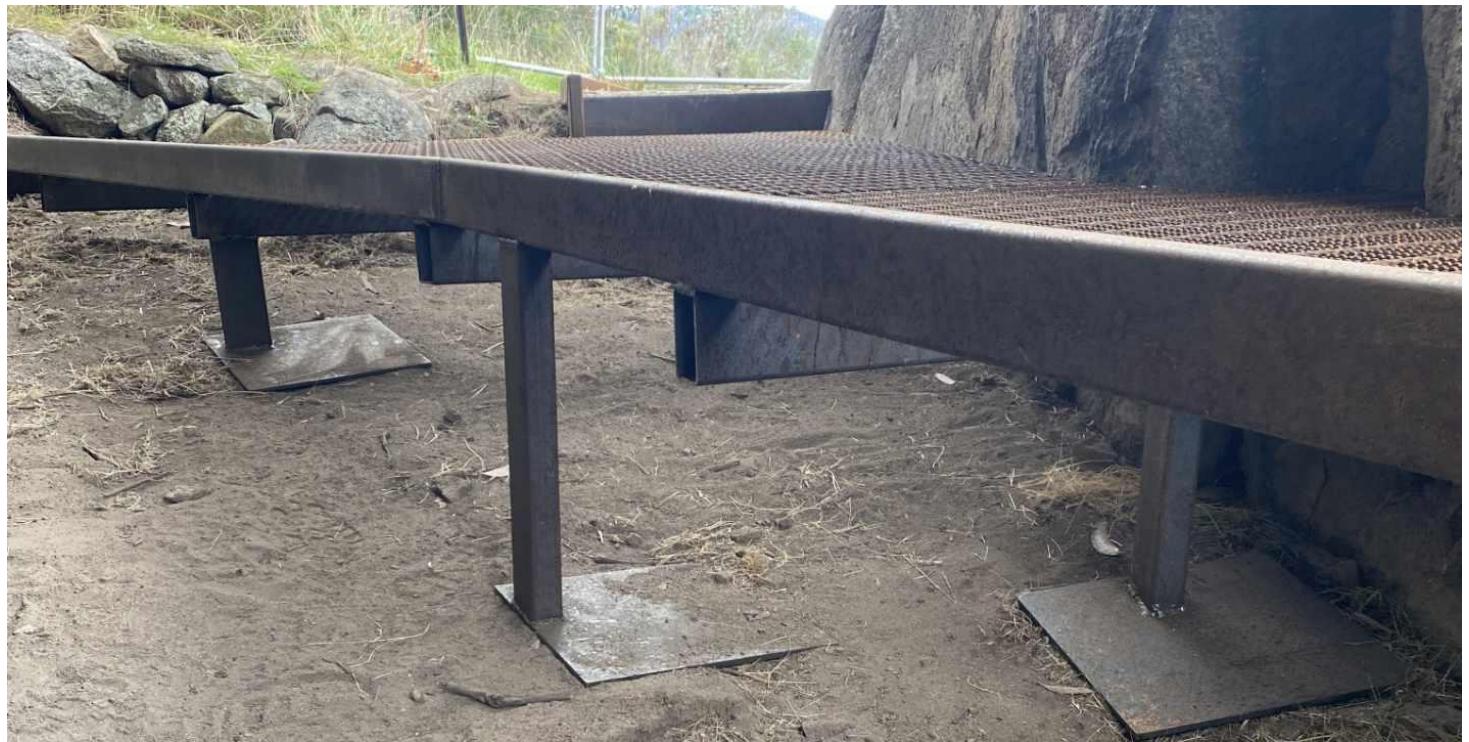
Steel plates support the new viewing platform so that it stands free of the rock and leaves the soil free of disturbance.

"Steel sections were custom designed leading to and from a steel platform which sits free of everything, on a series of steel plates. No soil was excavated: we didn't even disturb the soil surface. Visitors now walk one-way past the art behind a handrail that has been carefully designed to prevent anyone from touching the art."

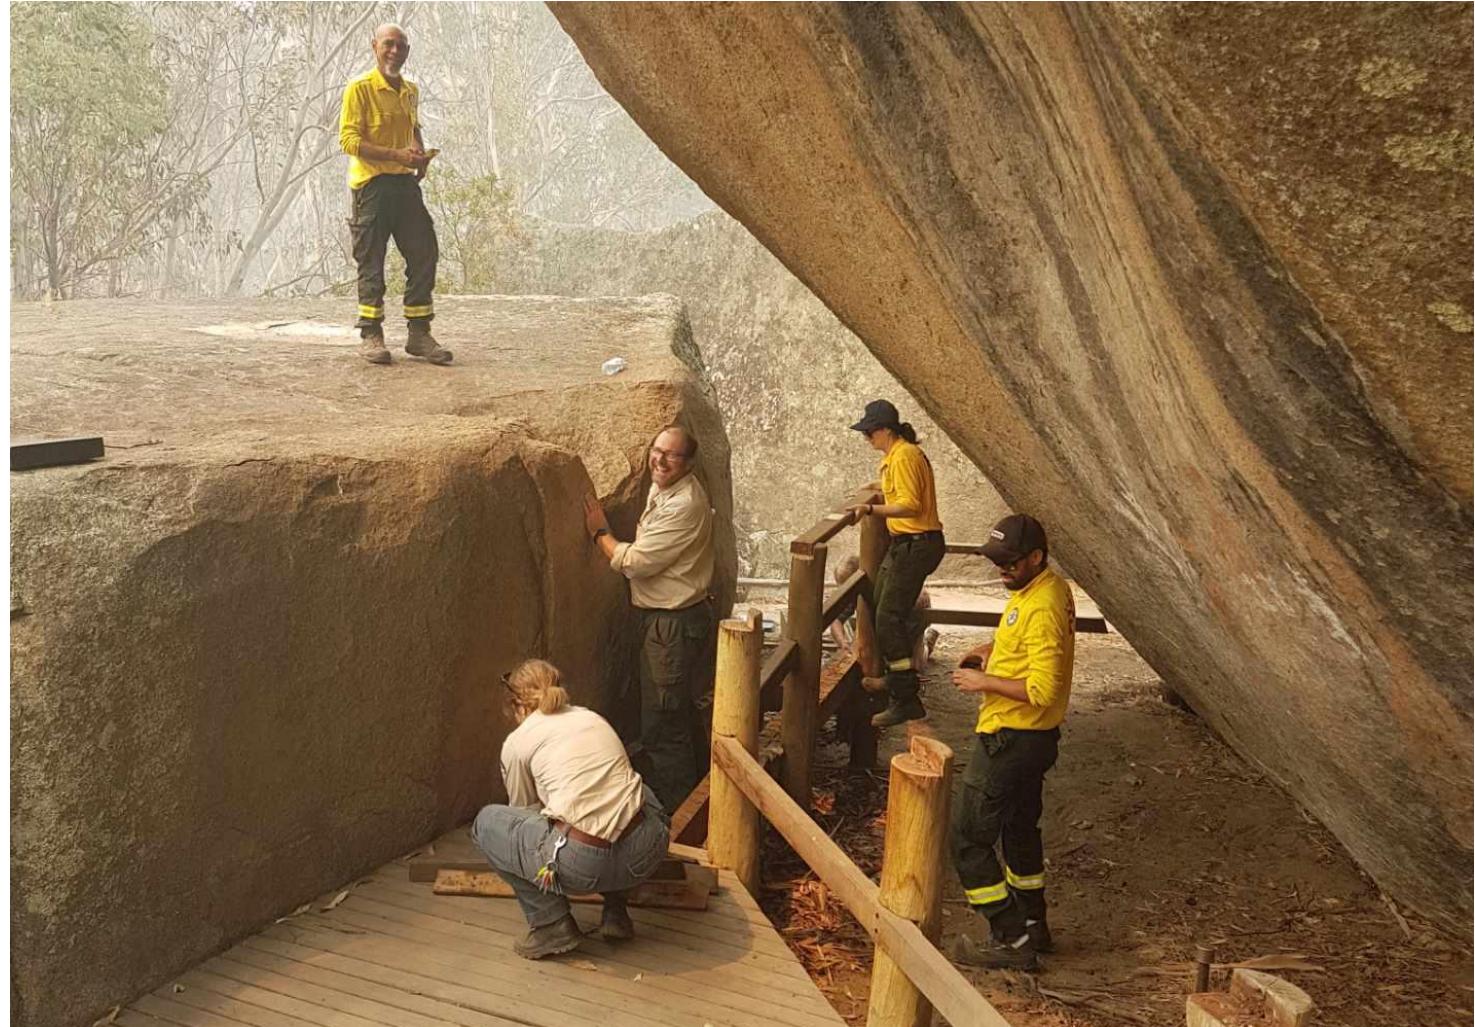
The last moments of the old viewing platform being removed ahead of the advancing fire.

"In 2020, when it became likely that the nearby Orroral Valley fires would spread to the Gudgenby Valley, we were frightened that the existing wooden viewing platform could catch alight and damage the rock art." So, a team was sent in armed with the tools to pull it apart and remove the posts. "Within a week we knew it had been the right call to make: the fire front moved right through the area, burning adjacent vegetation as well as the wooden boardwalks lying further back up the track."

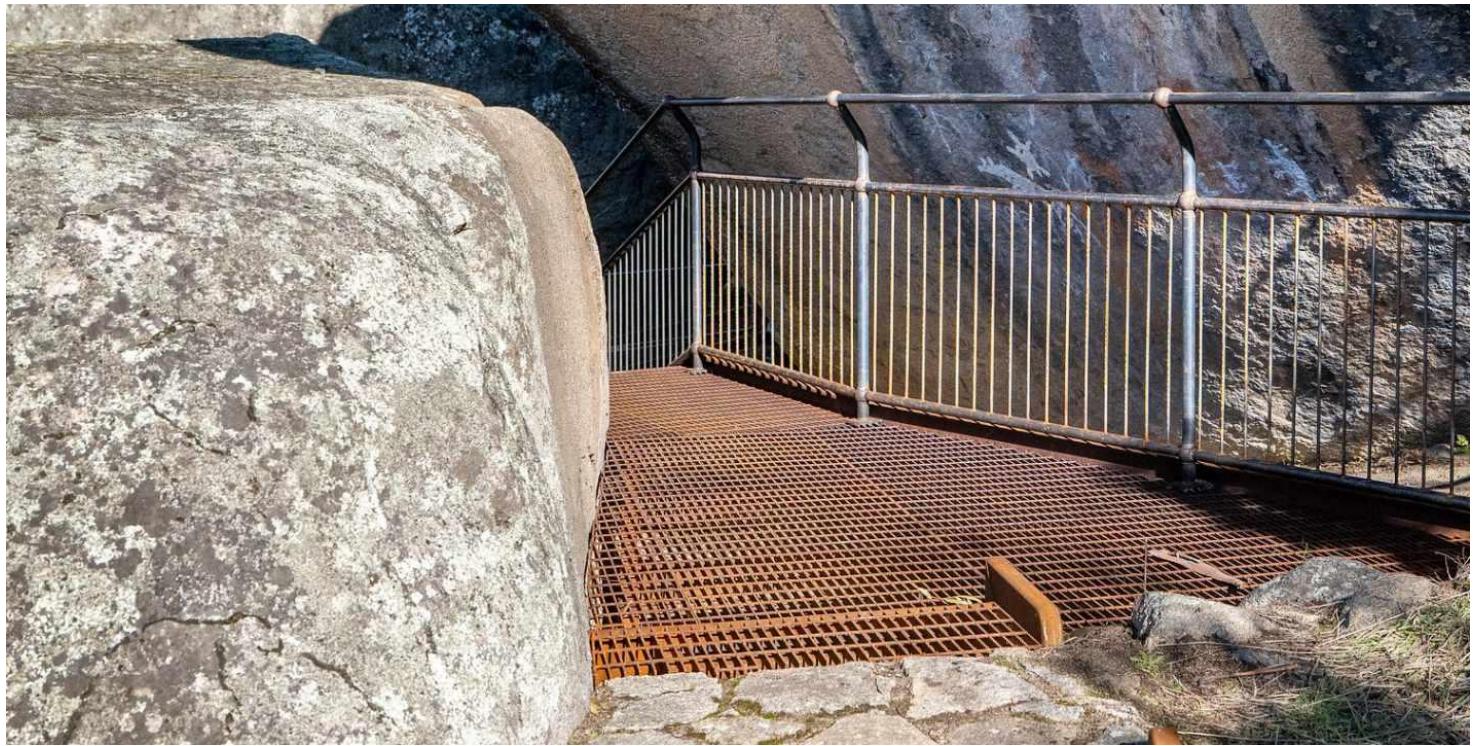
Sensitive design shows in the detail where steel meets the rock, bringing people up to the rock art face at a safe distance: the art can be glimpsed at right but is best experienced by walking the track.
